Manhole Inspection Summary

Manhole # S53C__019MH

Inspection ☐ Is Incomplete Rating: **3) Fair**

Location Address: **1 n clinton st**

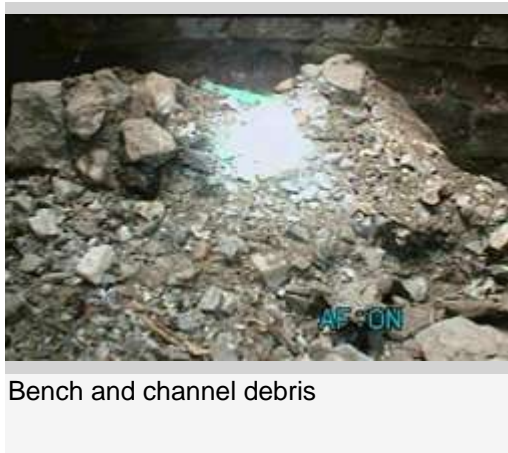
Defect 3

Condition: ☐ Sound ☐ Cracked ☐ Root Intrusion ☐ Deteriorated ☐ Leaks ☒ **Debris**

Bench and channel debris

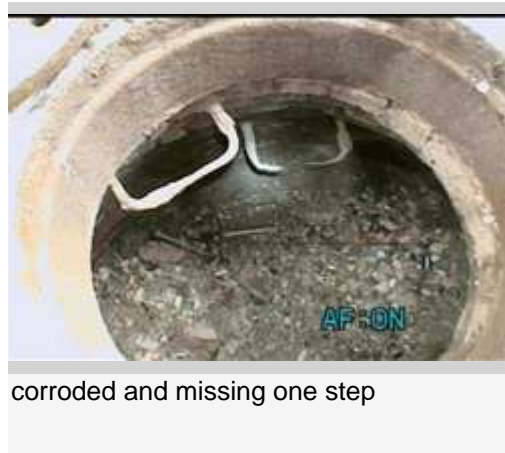
Defect 2

Steps Count: **2** Missing: **1** ☒ **Corroded**

corroded and missing one step

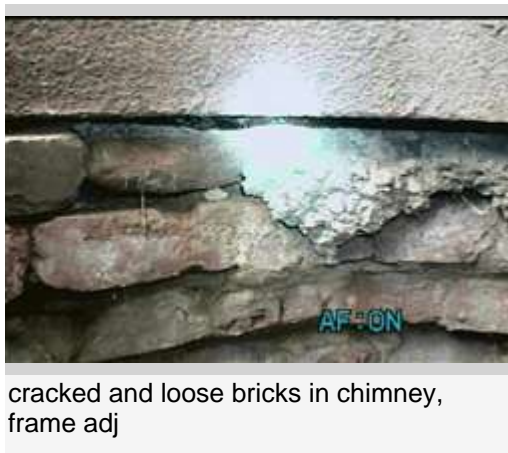
Defect 1

Condition: ☐ Sound ☒ **Cracked** ☐ Root Intrusion ☒ **Loose Brick** ☐ Deteriorated

cracked and loose bricks in chimney,
frame adj
